# **St Mary and All Saint's Church, Droxford Wall paintings in the north chapel**

**Wall paintings in the north chapel - Detailed Condition Report**

April 2015

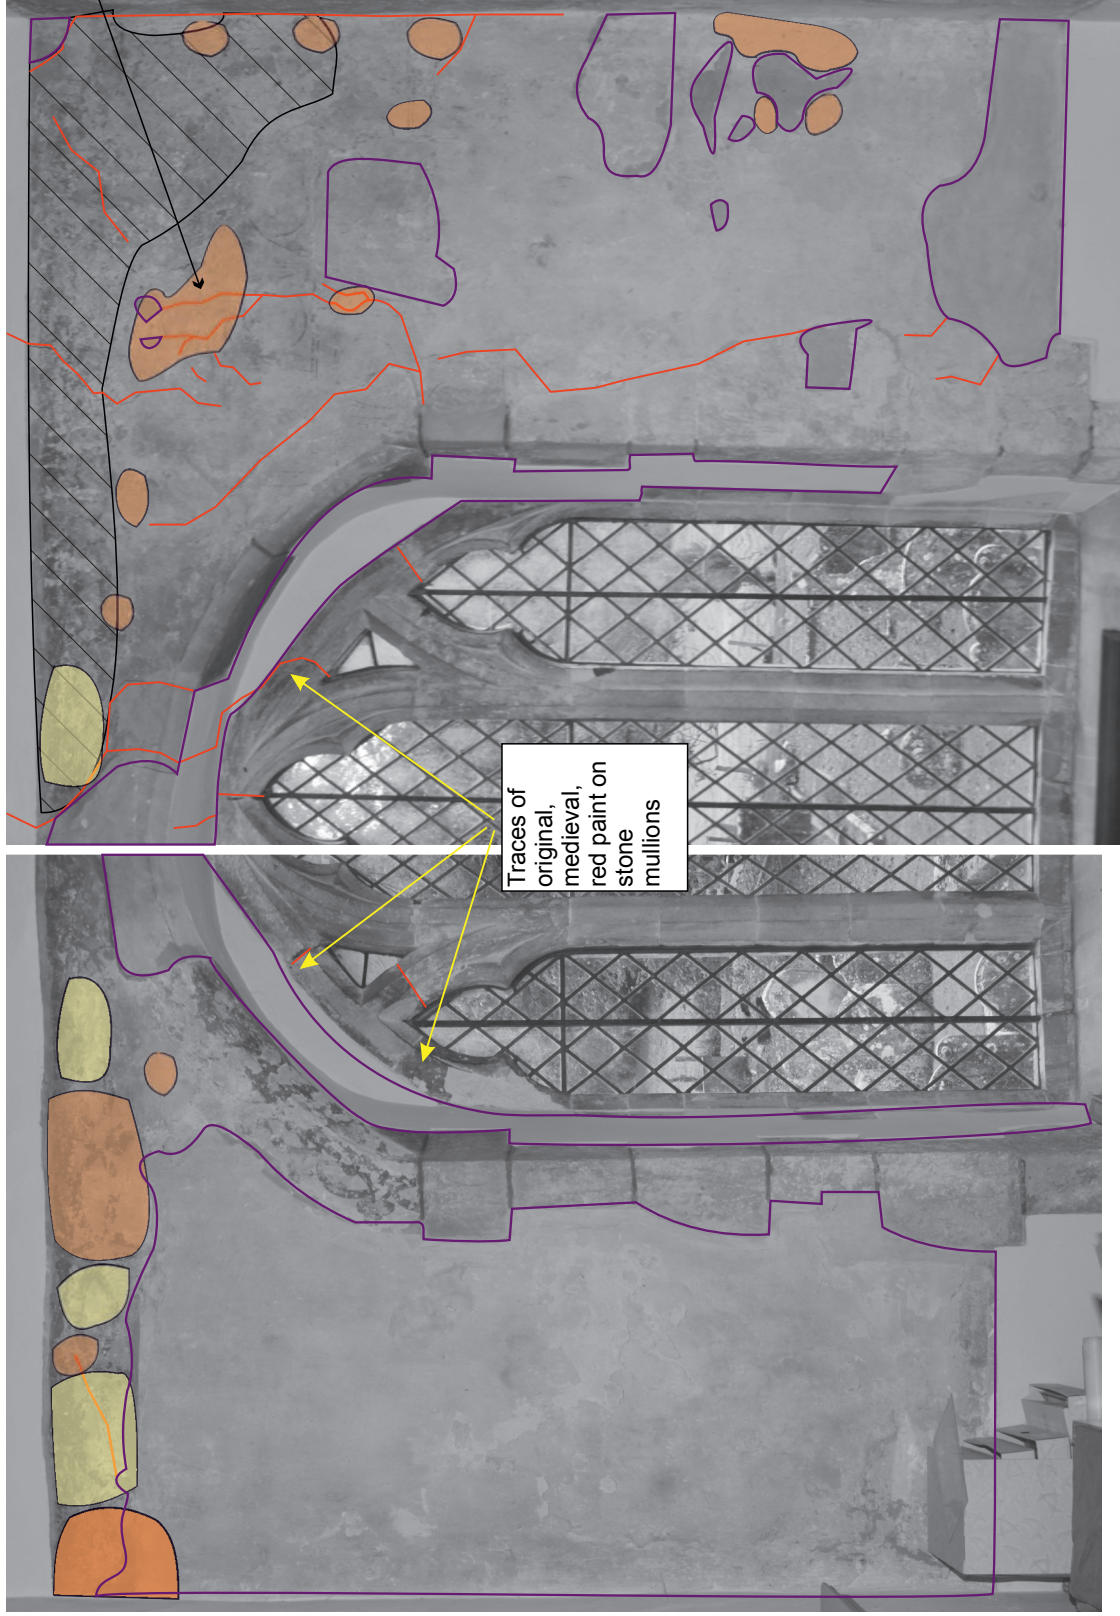
**Illustration 3 - condition wall paintings**

Illustrations 3 & 4 map aspects of the condition of the wall paintings on the east and south walls. Of most concern are areas of detached plaster where consolidation is required. The most significant area at risk is highlighted in illustration 3 (photo 16) where there are a number of cracks in the plaster. Other areas of concern are at the top of east wall, north end (photo 17); and around the vertical or near vertical cracks on the south wall.

Investigations have shown that the wall paintings are stable and not deteriorating. There are, however aspects of their present condition which are of concern, and of these the most significant are areas of detached plaster as shown in illustrations 3 & 4. This is of particular concern in view of the work proposed to the exterior of the chapel; removal of cement and structural repair to the east window. Areas of detached plaster need to be secured using a lime slurry or lime based grout.

- Decommission the radiator on the south wall and remove it.
- Secure areas of detached plaster where treatment is necessary (see illustrations 3 & 4) using lime slurry or a lime based grout.
- Fill cracks and open joints with lime mortar, and tone to match their surroundings.
- Secure small localised areas where plaster is vulnerable, and where paint is flaking.

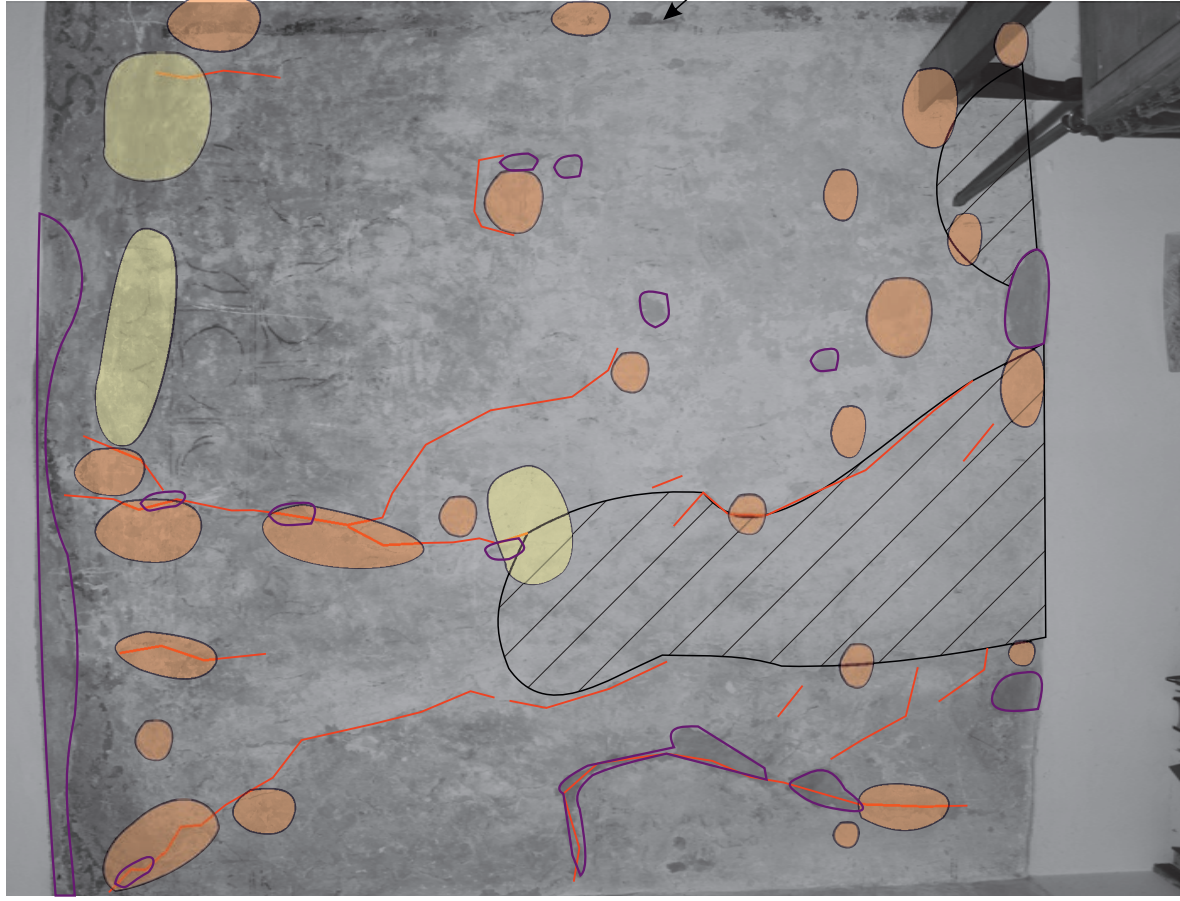
**Illustration 4 - condition wall paintings**

Some of the decoration lies over an area of repair plaster; see illustration 4, photo 13. This shows that some repairs to the internal walls of the chapel, which predate the wall paintings, were required in advance of painting.

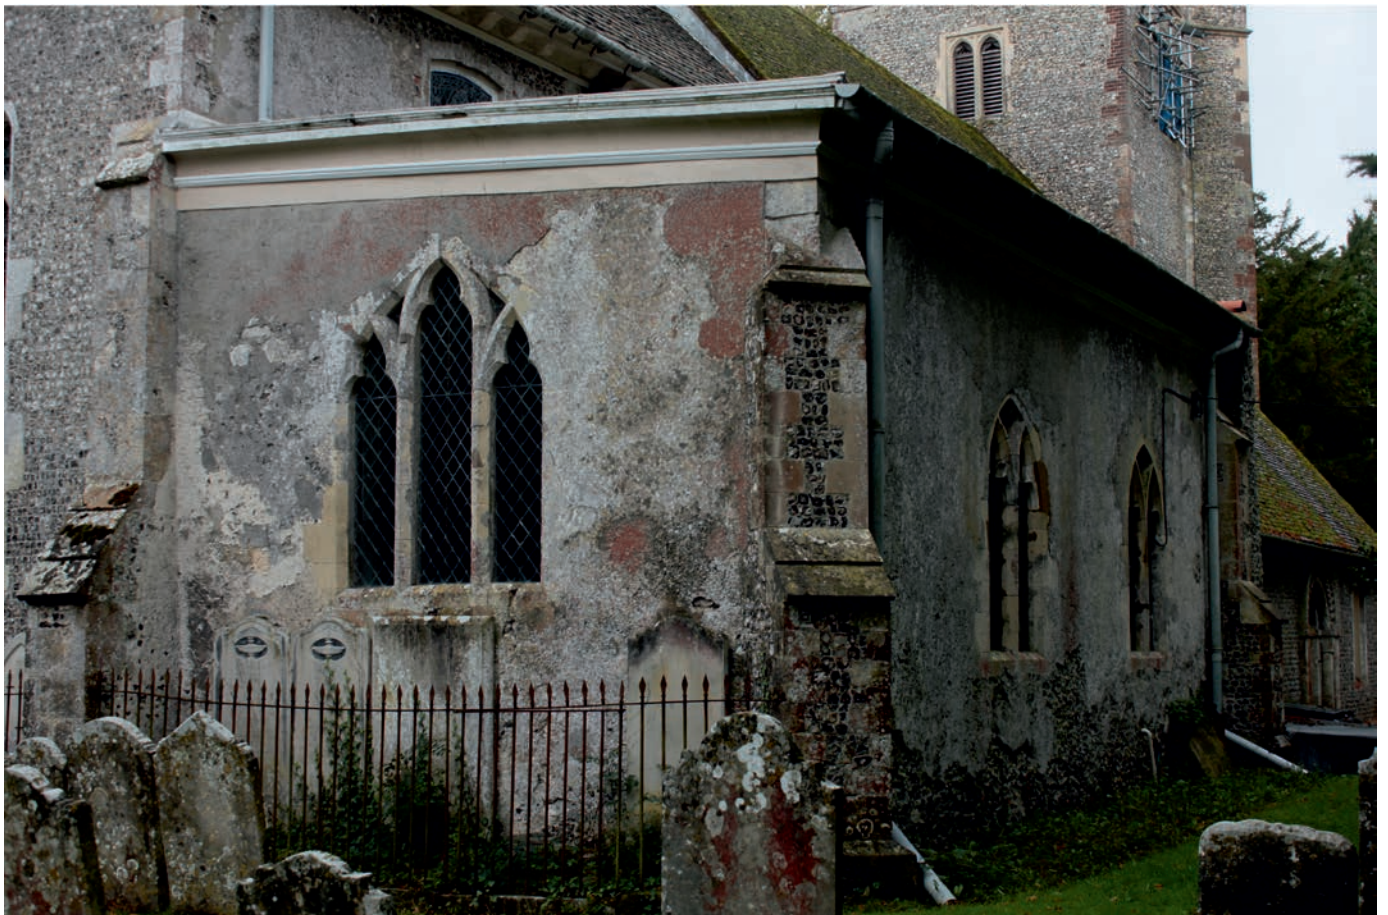
2 - Below, the north chapel. Patch repairs with cement render can be seen on the upper parts of the east and north walls; four gravestones have been set against the eastern wall of the chapel.

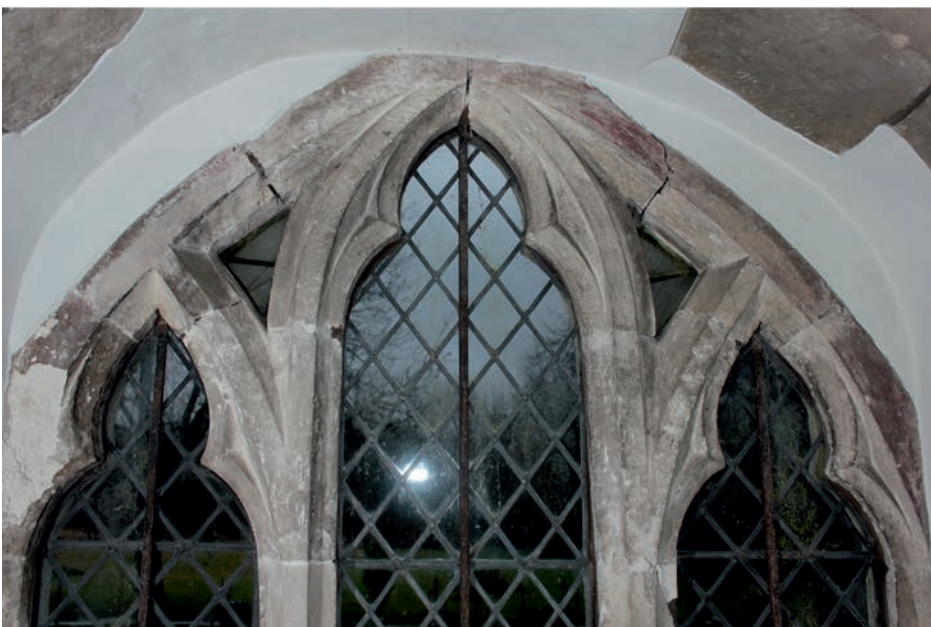
Interest with the condition of the wall paintings has been heightened as a result of proposals to make improvements and repairs to the fabric of the church, rainwater disposal and drainage. Some repairs are due to be carried out to the east wall of the north chapel upon which there are wall paintings. In particular those repairs are concerned with the stonework of the east window. The arch of the window has dropped and there are a number of cracks internally in the wall, some joints in the stone tracery have opened: see illustration 3 and photos 1, 2, 3 & 7.

7 - Left, the upper part of the east window. Traces of medieval paint (red) are especially apparent toward the top of the window tracery. There are a number of open joints in the tracery, indicating structural movement.

Cracks in the plaster, and joints in the window tracery should be filled with lime mortar, and that mortar toned to match the surrounding areas.

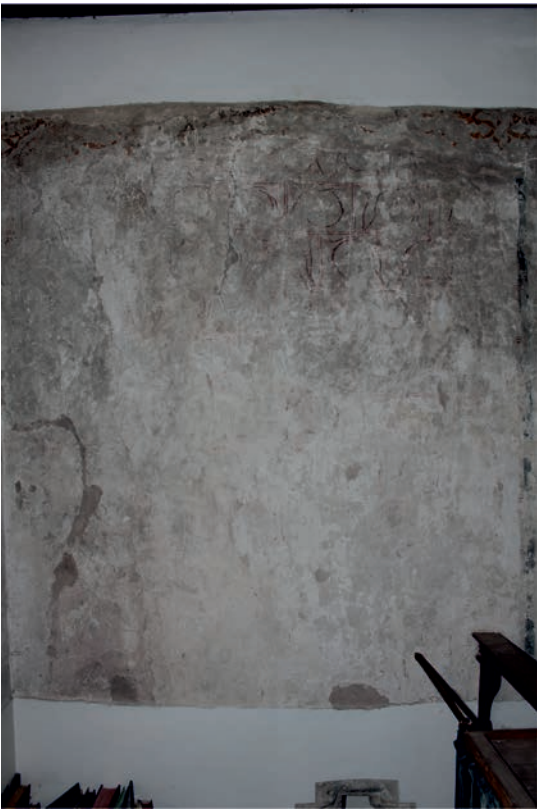
There are a number of darker plaster repairs within the areas of wall painting, see photos 8 & 16. Their darker tone detracts from the overall appearance, something which could be overcome by toning them using coloured limewash which matches the background of the wall paintings.

8 - Left, the eastern end of the south wall where the best area of C14 fictive masonry line decoration remains. Part of a vertical black line remains at the western end of the area of wall painting. A radiator is located below it at the eastern end.

It is possible to improve the aesthetic appearance of the wall paintings by cleaning, a matter which is not essential, but desirable. Similarly it is desirable to tone out dark plaster repairs to the background colour and tone of the surrounding wall painting.

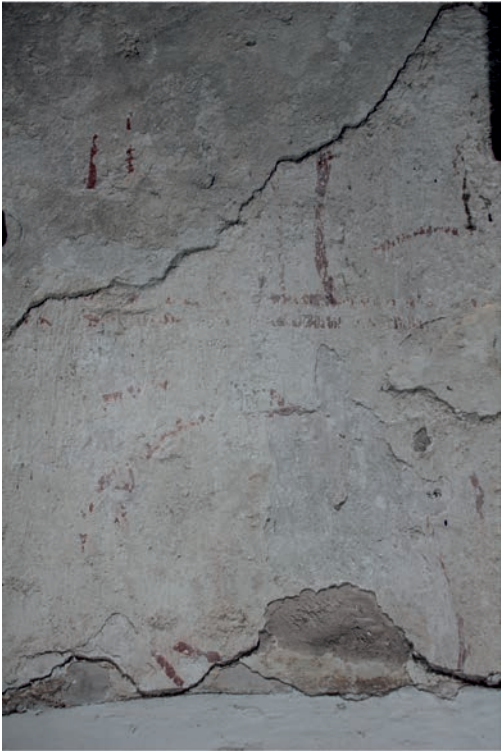
13 - Far left, area of replastering carried out before the C14 scheme was applied. See illustration 4.

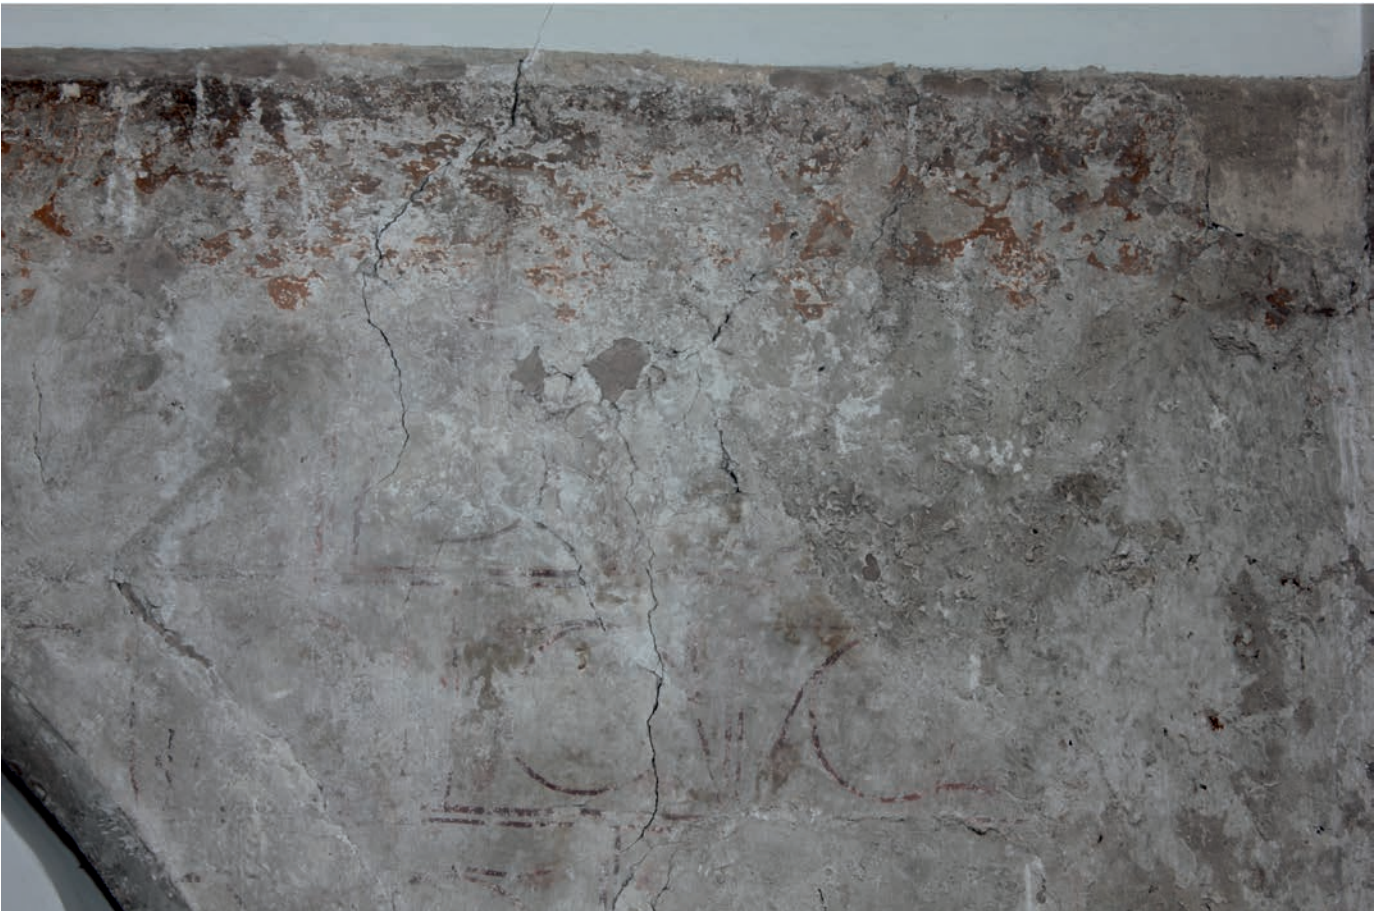
Another interesting aspect of the decoration on the east wall is that some lies over plaster repair at the south end of the east wall; see illustration 3, photo 16. This suggests deterioration and loss of the original scheme, rectified before implementing the second scheme.

16 - Below, detail from 15 showing painted decoration from both the C14 and the later scheme (C15 or early C16?). The condition of the plaster in this area is poor, there is much detachment. Evidence for the detachment can be seen in the number of cracks in the plaster. Please also see illustration 3.

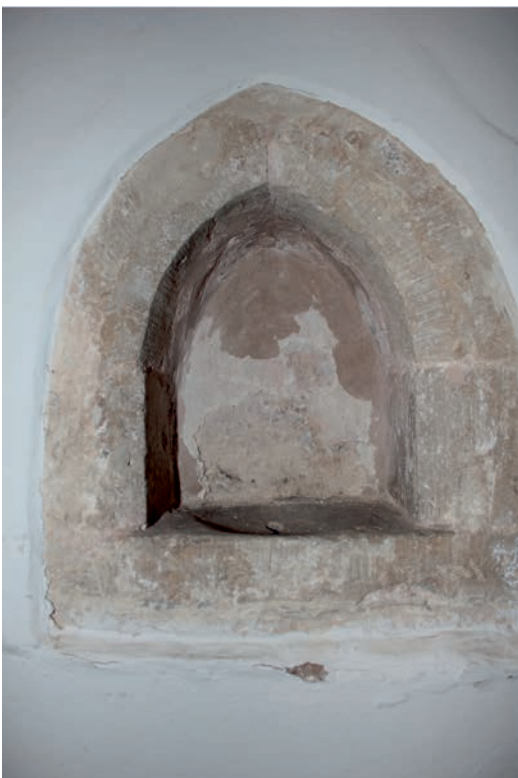
The back wall of the piscina retains much original plaster upon which there is red medieval paint (like red ochre); photos 25 & 26. As with the ambry, it is important to retain this decoration. Loose edges of plaster need to be secured.

25 - Left, the Piscina, in the south wall of the north chapel, to the west of the Ambry. As with the Ambry some medieval paint remains on this furnishing.

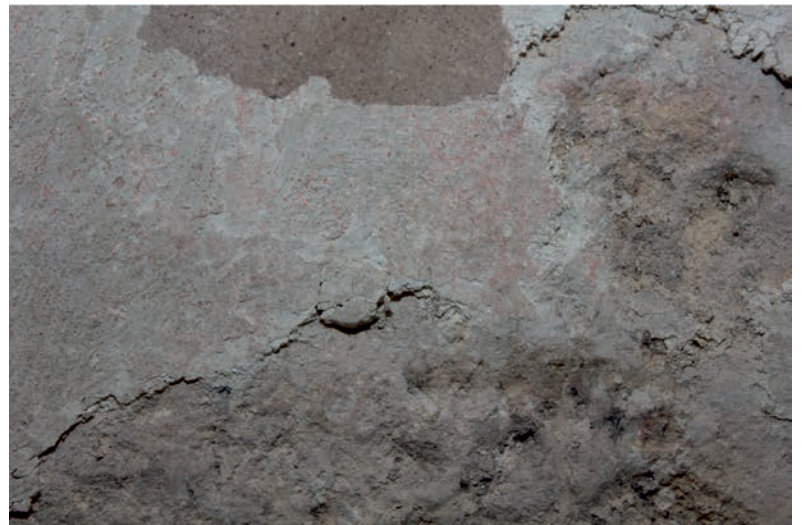
26 - Above, detail from 25 showing original painted plaster at the back of the Piscina.
